**GEOHYDROLOGICAL ASSESSMENT STUDY FOR A GENERAL  
WASTE LANDFILL SITE AT WALKERVILLE LOCATED ON THE R82  
NORTH OF VEREENIGING**

**Report No: G 2010/015**

**March 2010**

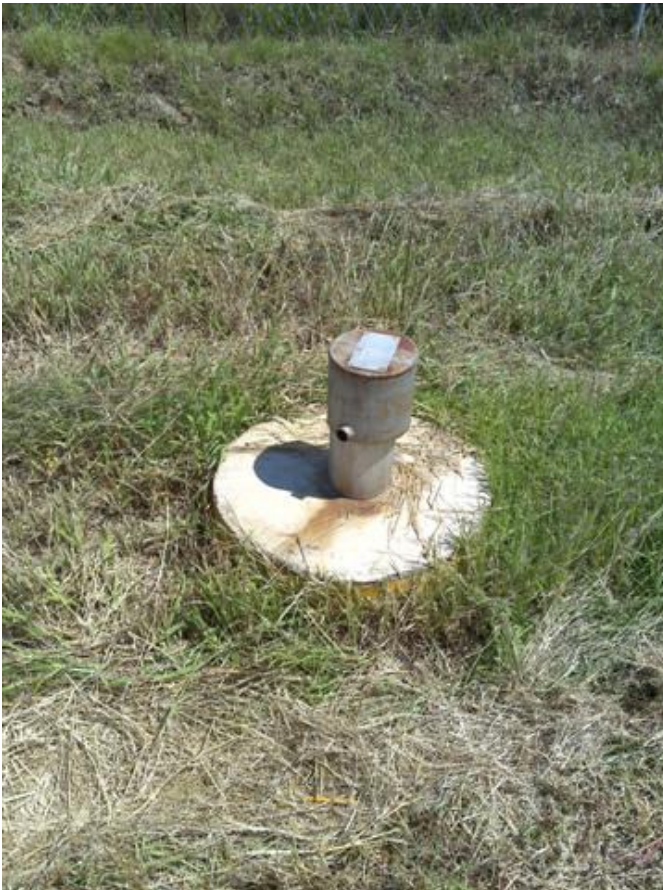
#### **Walkerville WBH1S**

Borehole was found on site, marked as WBH1S, but no mentioning is made of this borehole drilled during the same study.

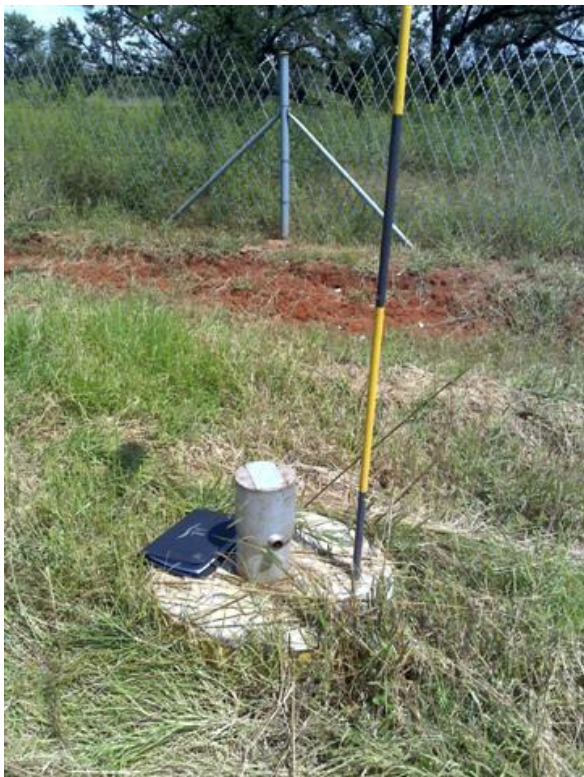
**Walkerville WBH1D**

Borehole was found on site, marked as WBH1D. 0 to 4 Hillwash. 4 to 14 Residual Andesite gravels. 14 to 16 Andesite weathered. 16 to 20 hard rock Andesite. 20 to 24 hard rock Andesite. 24 to 40 hard rock Andesite. Water strike encountered at 13 metres.

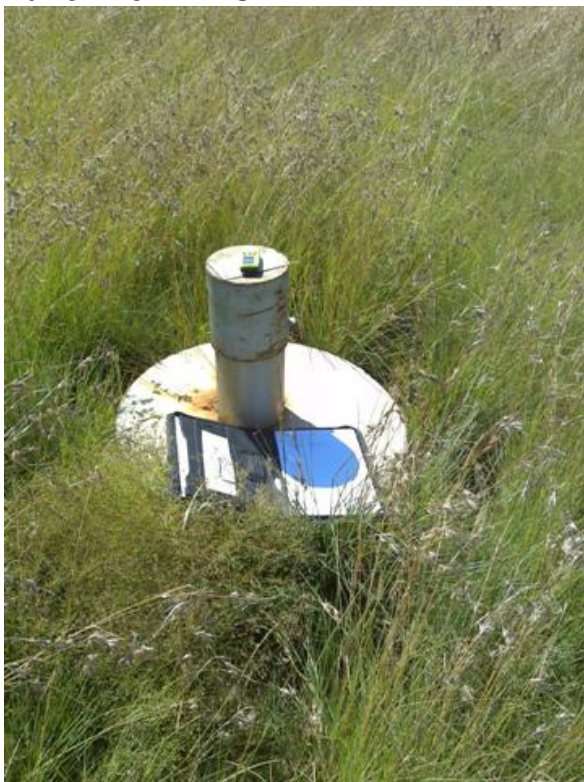
**Walkerville WBH2S**

Borehole was found on site, marked as WBH2S, but no mentioning is made of this borehole drilled during the same study.

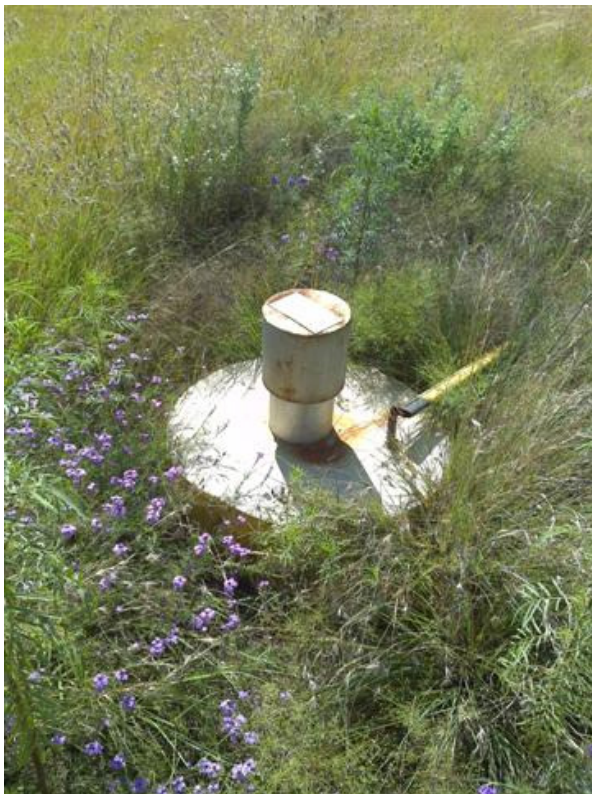
**Walkerville WBH2D**

Borehole was found on site, marked as WBH2D. 0 to 1 Hillwash. 1 to 5 Residual Andesite gravels. 5 to 13 Soft rock Andesite. 13 to 15 Soft rock Andesite. 15 to 20 Jointed Andesite. 20 to 40 hard rock Andesite. Water strike encountered at 13 and 36 metres.

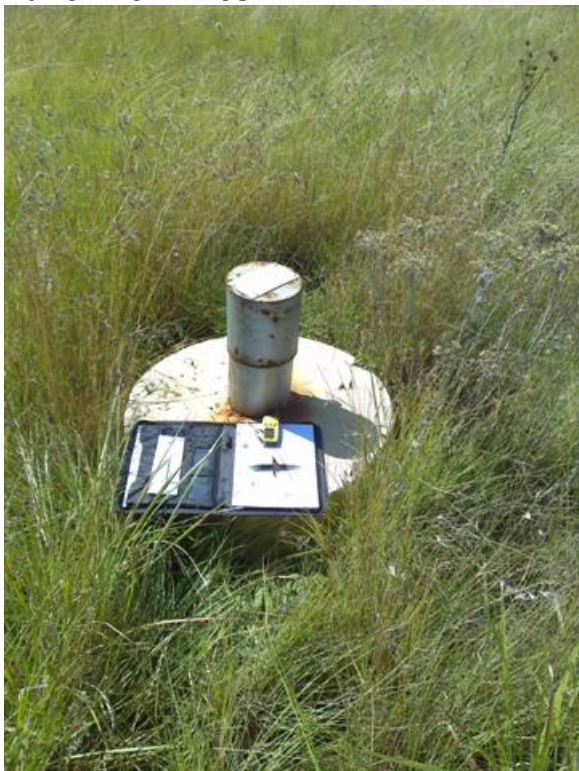
**Walkerville WBH3S**

Borehole was found on site, marked as WBH3S, but no mentioning is made of this borehole drilled during the same study.

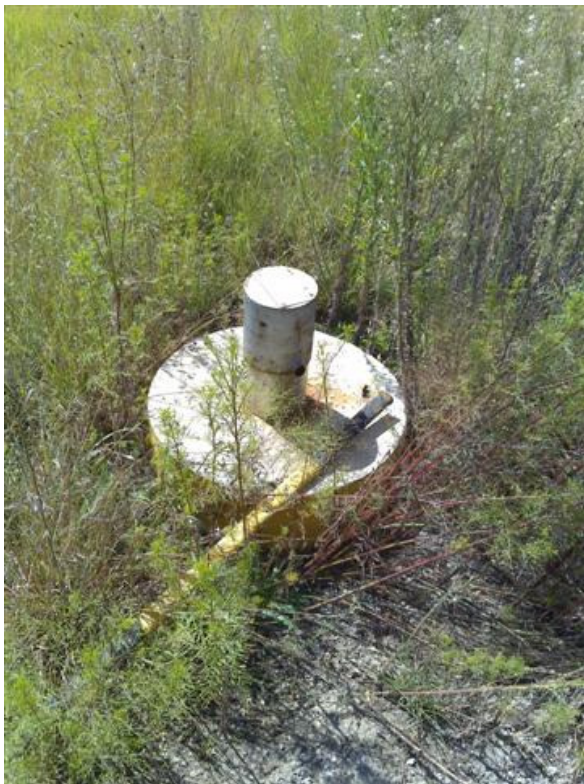
**Walkerville WBH3D**

Borehole was found on site, marked as WBH3D. 0 to 4 Hillwash. 4 to 14 Residual Andesite

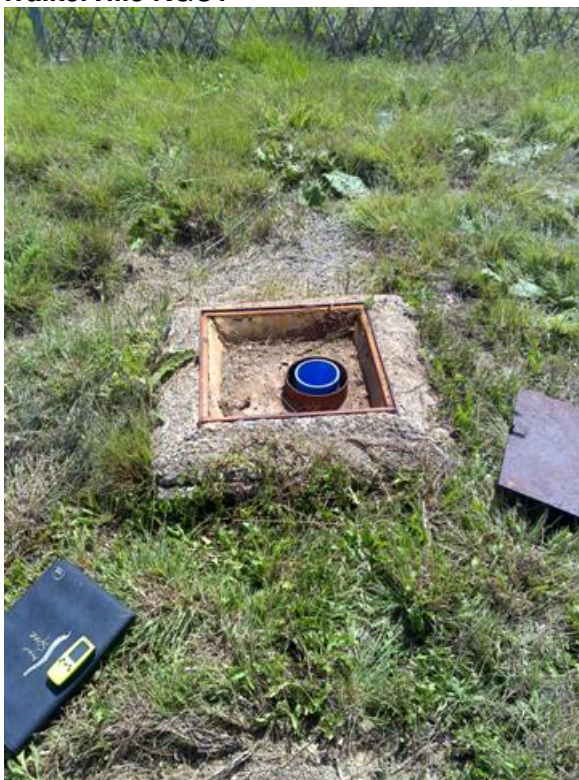
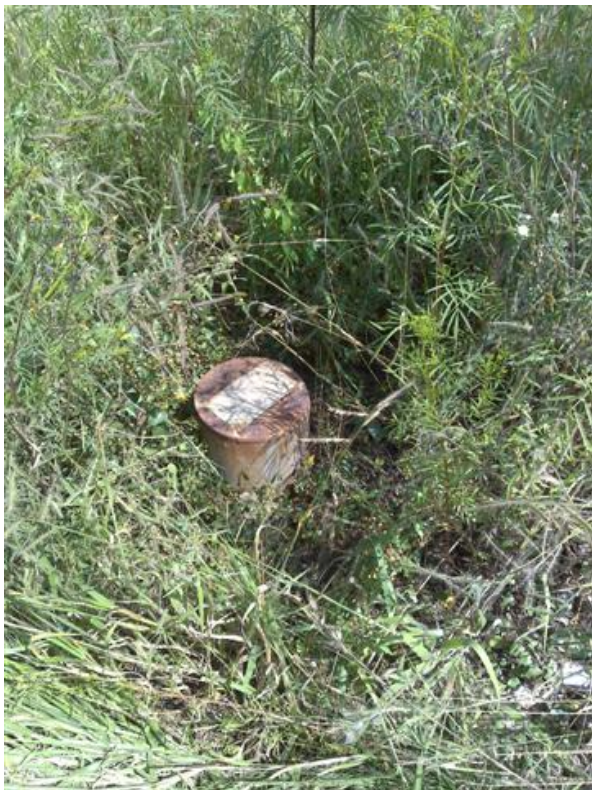
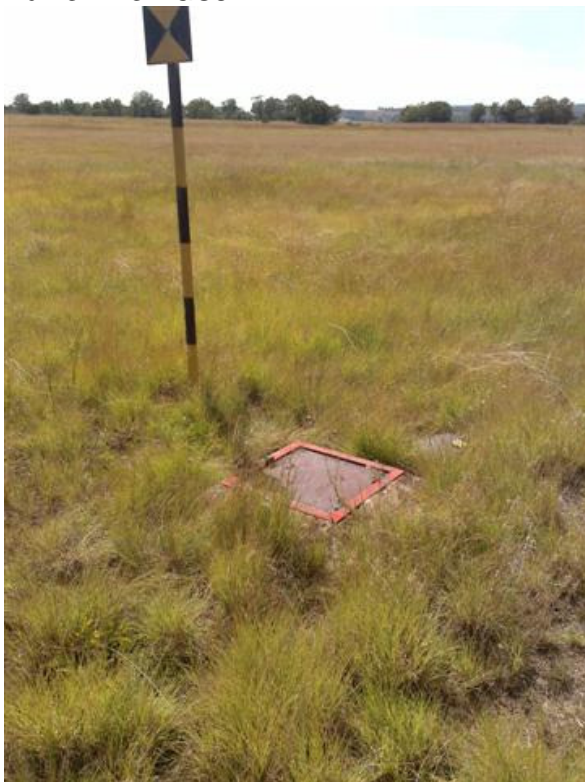
The “Walkerville Landfill Site Testpit Investigation” study of Jones & Wagener report on the three existing monitoring boreholes KGC1 to KGC3. No further information about monitoring boreholes KGC1 to KGC3 is revealed. They also drill the new monitoring boreholes WBH1 to WBH3. No mentioning in their report is made that these three boreholes rather consists of three sets of deep and shallow boreholes which are numbered WBH1S, WBH1D, WBH2S, WBH2D, WBH3S and WBH3D. We however believe that these three sets of deep and shallow boreholes (six in total) were constructed during this study.

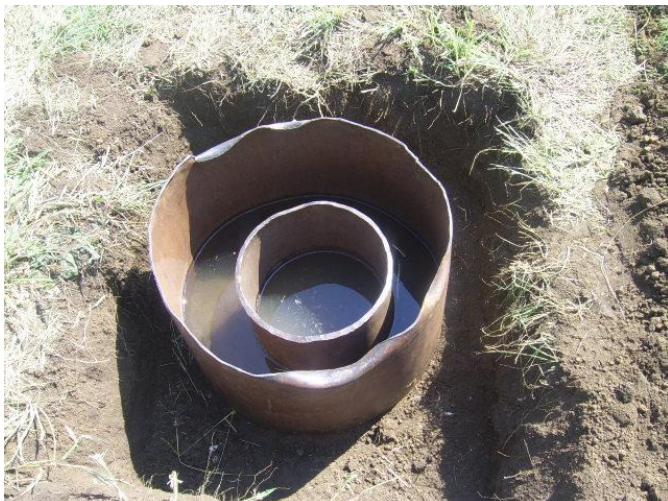
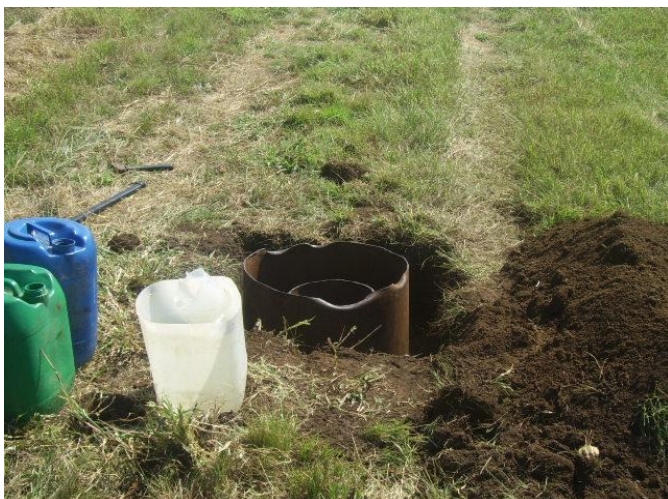
**Test Pit 1**

The soil's hydraulic conductivity measured in test pit TP1 is  $4.42 \times 10^{-4}$ cm/s or 1.5899cm/h or 0.3816m/d, whilst the hydraulic conductivity in test pit TP2 is  $6.92 \times 10^{-3}$ cm/s or 24.91cm/h or 5.98m/d. Test pit TP1 are located on the top soil material covering the landfill site whilst test pit TP2 are located on weathered and fractured Andesite.

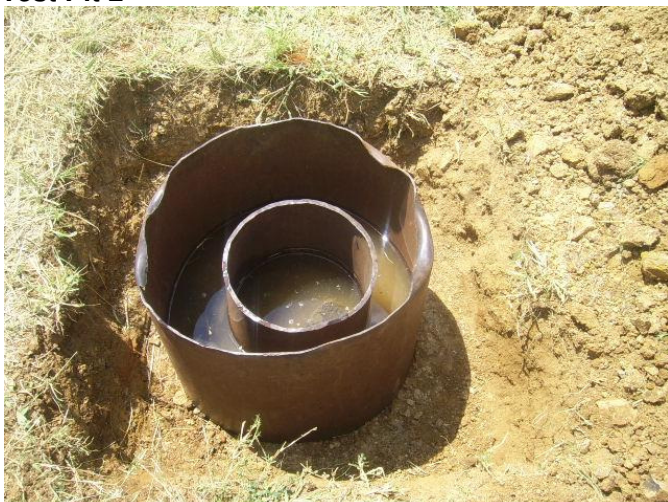
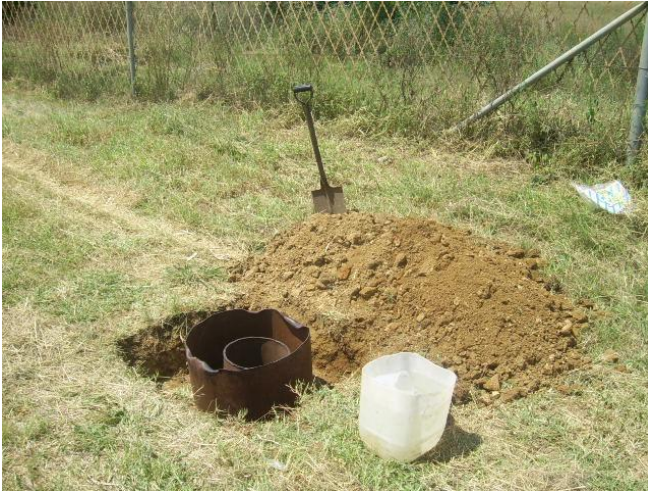
**Test Pit 2**

From these two tests it can be seen that the weathered Andesite host rock is ten to twenty times more permeable as the clayey top soil found on site. The study from Jones & Wagener found the soil material on site suitable to construct a lining layer on the bottom of the landfill site and to use it as covering material. We recommend this to be done to lower the infiltration rate of water into the weathered Andesite rock strata.
